TREATMENT PLANT OPERATOR

tpomag.com  
JUNE 2016

## Oxygenation system prevents odor and corrosion in force main

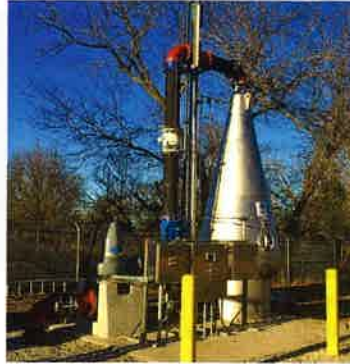
The city installed an **ECO2 SuperOxygenation System** from **ECO Oxygen Technologies**. The system dissolves high levels of oxygen in a wastewater sidestream that is then blended back into the force main. Automated controls pace the oxygen feed to ensure sufficient dissolved oxygen in the line to maintain aerobic conditions. Hydrogen sulfide is effectively eliminated. The system consists of a stainless steel cone, automated system controls and a sidestream pump that is the only moving part requiring standard maintenance.

The day the system was turned on, hydrogen sulfide concentrations rapidly decreased from over 600 ppm to an average of 2 ppm. **317/706-6484; www.eco2tech.com.**

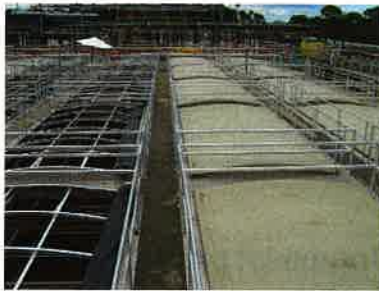
The utility chose retractable **cover systems** from **Geomembrane Technologies** to capture foul air while allowing workers quick and easy access to tank internals. The system consists of fabric covers tensioned over aluminum arches. The design includes inspection hatches and clear-span guardrails that allow the covers to be safely opened and closed without interference from standard guardrail supports.

The covers control odors, while protecting plant infrastructure and allowing operations and maintenance teams to perform their work. The ventilation system allows the covers to maintain a negative pressure of around -20 Pascal and achieve more than 99 percent odor capture. **506/449-0993; www.gtcovers.com.**

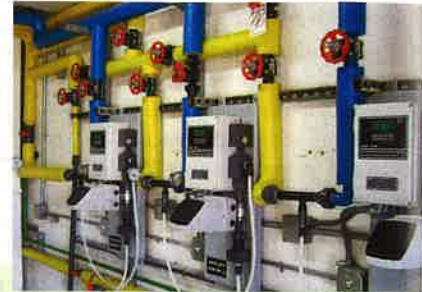
The facility turned to **JCS Industries** for a next-generation **vacuum feeder** without the troublesome diaphragm. Before making the switch to the replacement liquid vacuum feeders, the operations supervisor had his engineering firm consider peristaltic and diaphragm pumping options. They found the replacement vacuum feed to be the most cost-effective.

The replacement feed system ended outages due to plugging and leaks, while providing a 30 percent reduction in bisulfite due to greater feeding accuracy. The instrumentation technician can now focus on his SCADA responsibilities, and plant operators can now focus on other plant operations. **281/353-2100; www.jcsindustries.us.com.**

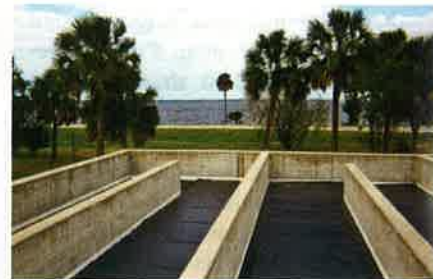
Both facilities installed **floating covers** manufactured by **Industrial & Environmental Concepts**. New York installed a floating cover on its pond, and Florida installed a cover on its chlorine contact chamber.

Covering the water surface eliminated penetrating UV and sunlight from the water column. Algae disappeared, chlorine demand decreased and residuals stabilized. Dosing expenses went down and disinfection improved with process predictability. **952/829-0731; www.ieccovers.com.**
